Materials for Oxygenated Wastewater Treatment Plant Construction

July 1978

TECHNICAL REPORT DATA (Please read Instructions on the reverse before completing)			
1. REPORT NO. EPA-600/2-78-136		3. RECIPIENT'S ACCESSION NO.	
4. TITLE AND SUBTITLE MATERIALS FOR OXYGENATED WASTEWATER TREATMENT PLANT CONSTRUCTION		5. REPORT DATE July 1978 (Issuing Date)

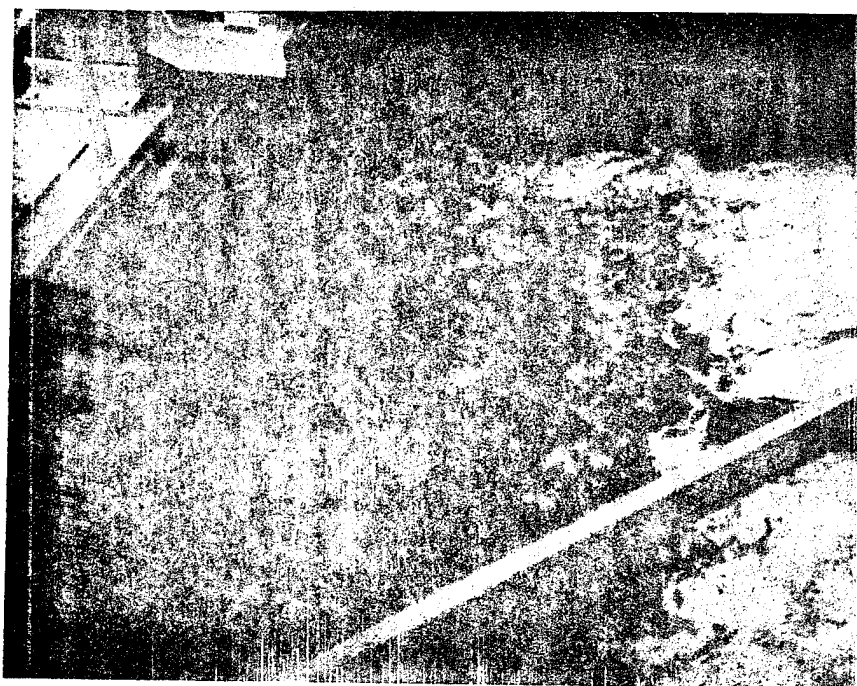
Figure 6. View of site 3 tank with cover removed to show splashing caused by the surface impeller. Test specimens were exposed to this splash zone effect.

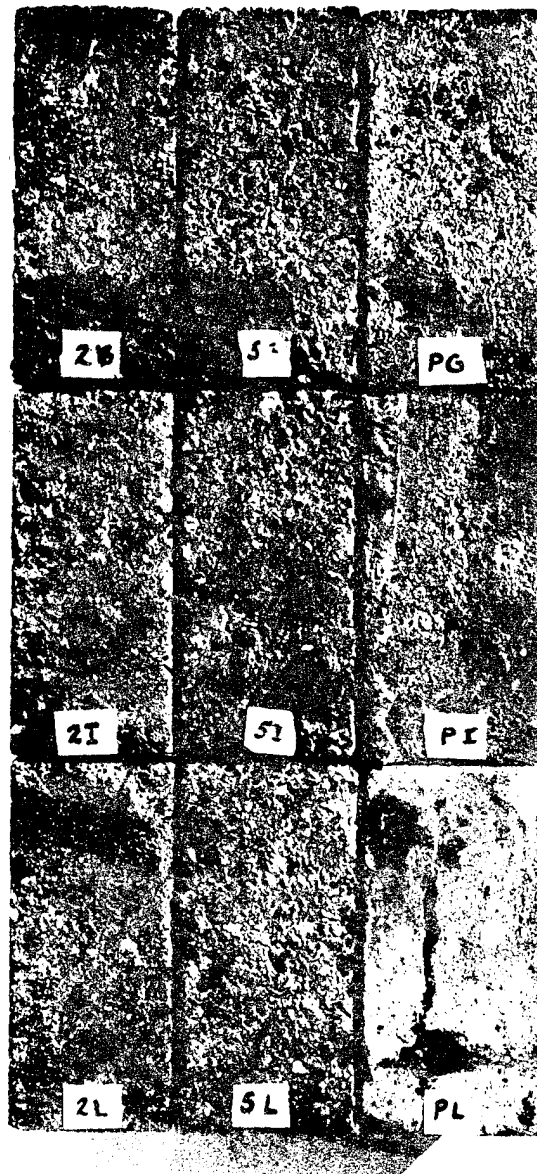
3. Surface conditions. - Generally, only minor changes in surface appearance have occurred at sites 1 and 2. At site 3, erosion of the surface was experienced as shown in figure 15.

a. Concrete made with Type V cement suffered the most severe erosion damage.

b. Less severe erosion damage was observed on concrete made using Type II cement.

Figure 15. - Concrete prisms exposed at site 3 for 28 months depict the damage due to surface abrasion. Prefix of specimen code denotes concrete type, i.e., 2-Type II, 5-Type V, and P-PIC; suffix indicates exposure, i.e., G-gas, I-interface, L-liquor.

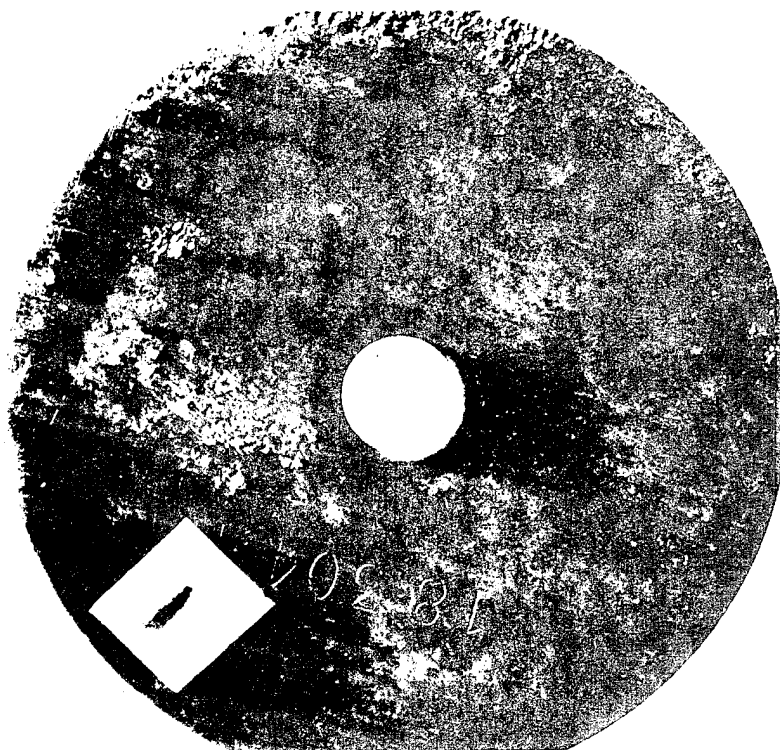
Figure 16. Sensitized Type 304 stainless steel specimen exposed in the gas zone at site 1 for 22 months. Note pitting due to sensitization.

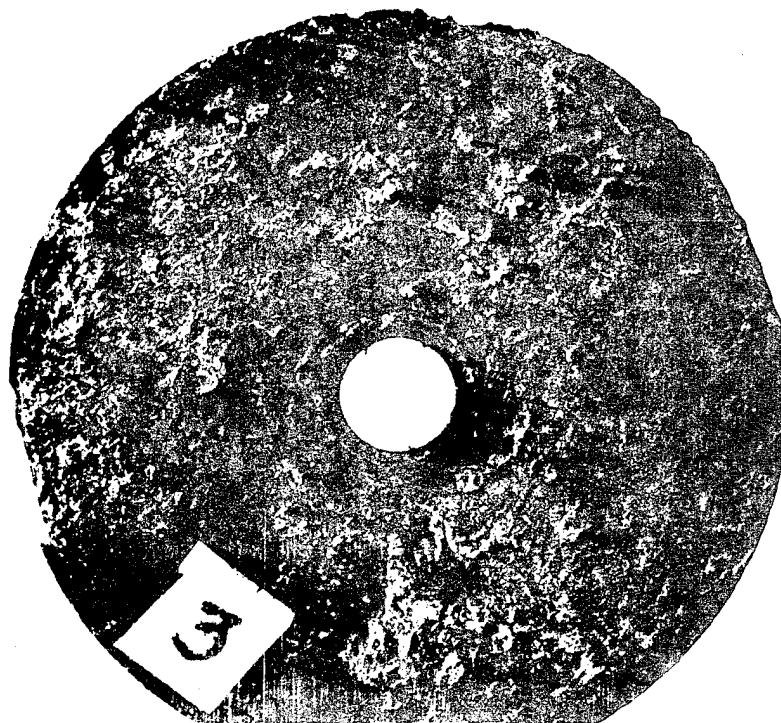
Figure 17. Mild steel specimen exposed in the gas zone at site 2 for 28 months. Surface is deeply pitted.

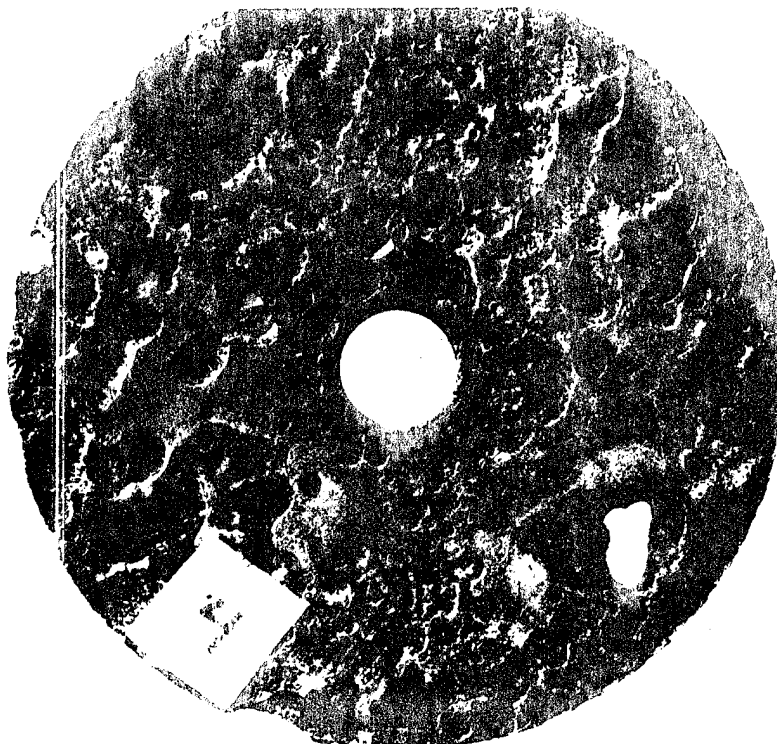
Figure 18. Low alloy steel specimen exposed in the liquor at site 2 for 28 months. Specimen is perforated.

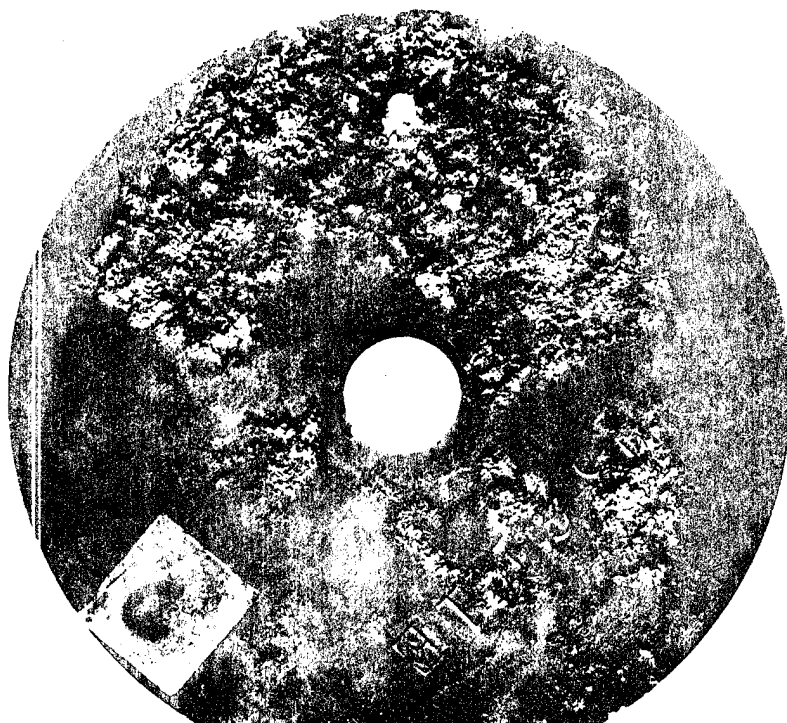
Figure 19. Aluminum alloy 6061 exposed in the gas zone at site 2 for 28 months. Sample is perforated.

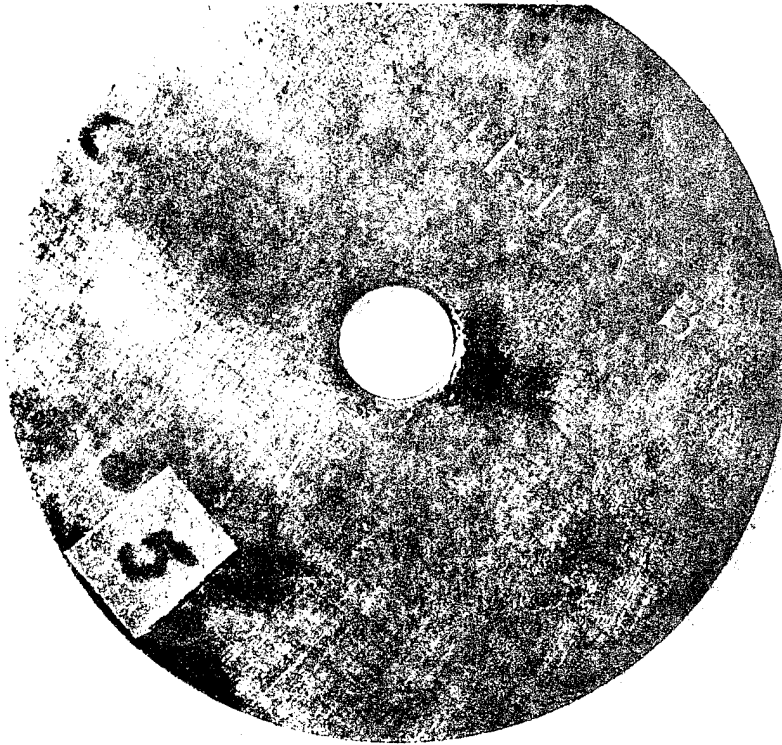
Figure 20. Copper specimen exposed in the gas zone at site 2 for 28 months. Sample is pitted in one localized area only.

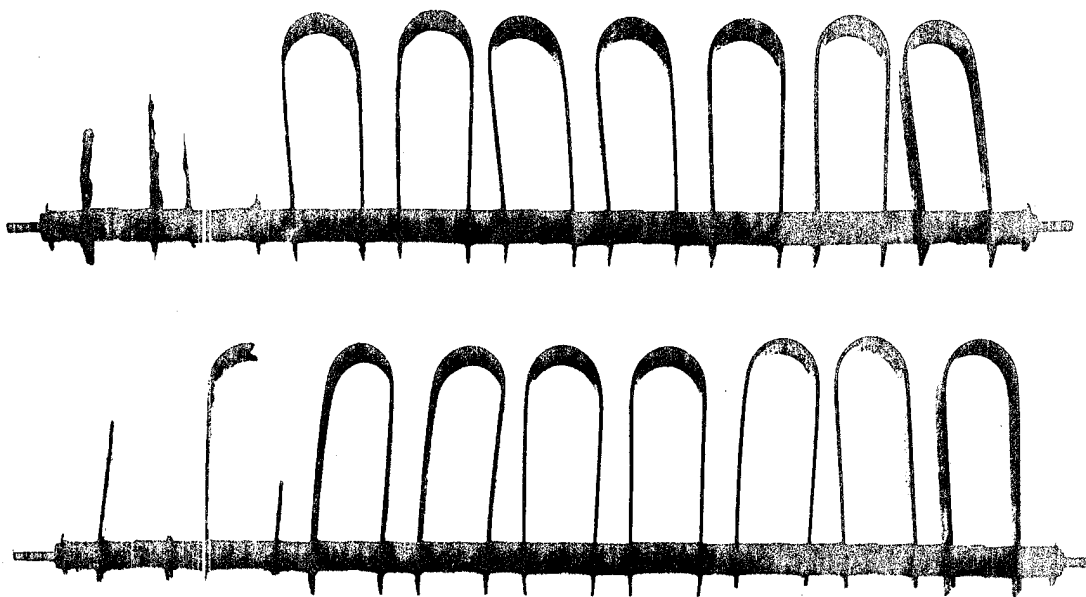
Figure 22. - Duplicate mild steel (top left) and aluminum alloy 6061 (bottom left) stressed specimens failed after 28 months' exposure in the liquor at site 2.

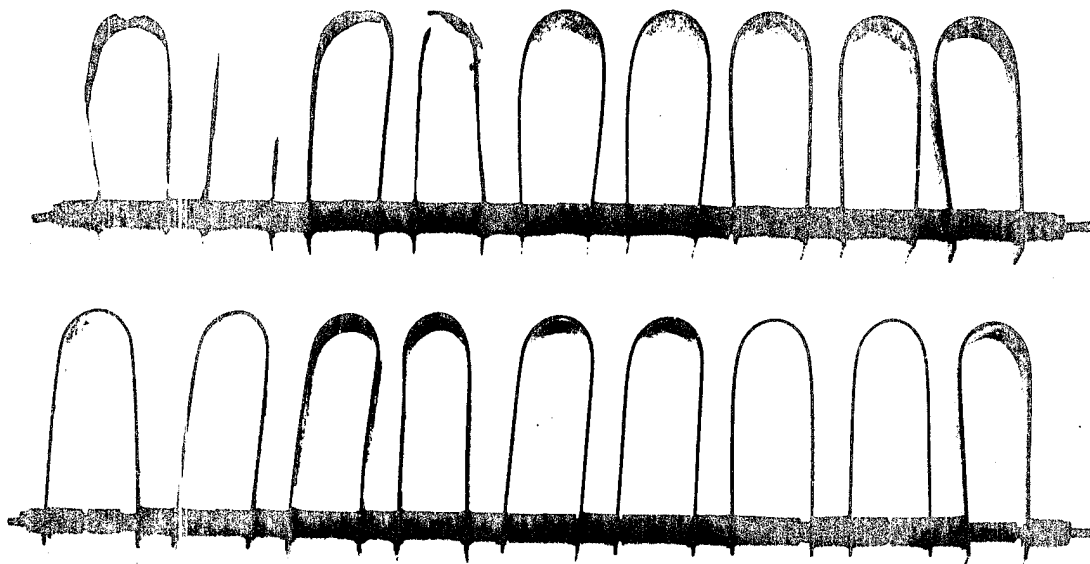
Figure 23. - Duplicate mild steel (first two samples, top row) and low alloy steel (second two samples, top row) stressed specimens failed after 28 months' exposure at the interface at site 3.

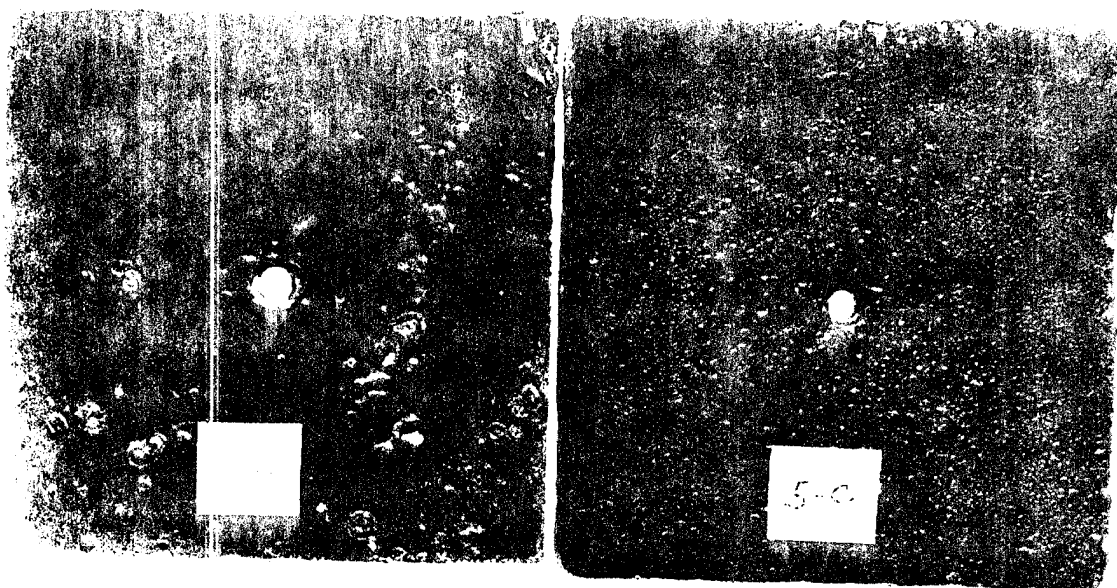
Figure 24. Blistering of proprietary butyl coating (No. C-6) on steel (left) and concrete substrates.

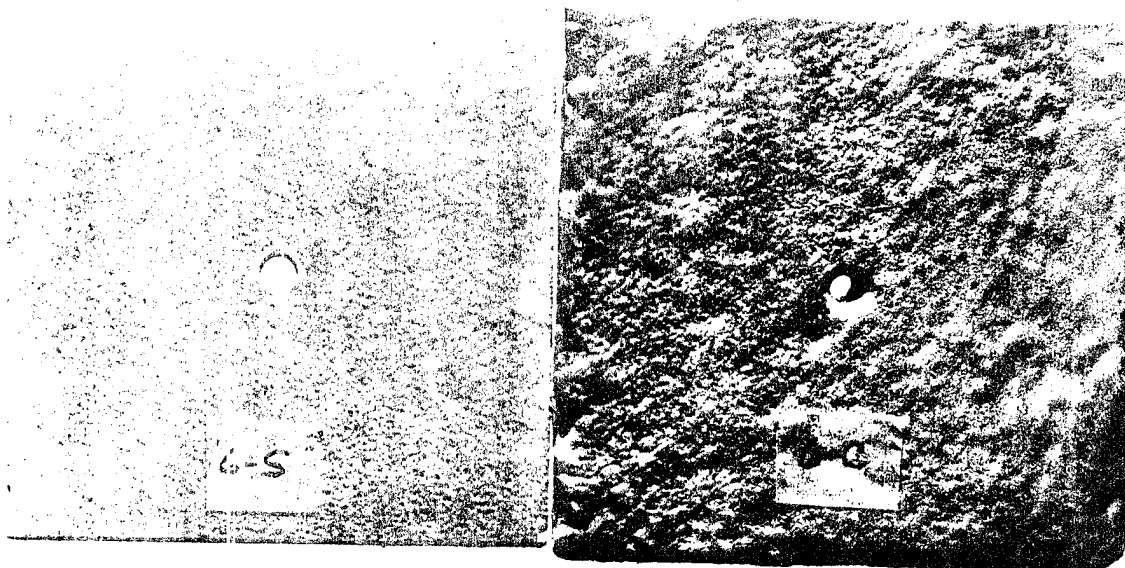
Figure 25. Defect-free proprietary urethane coating (No. C-9) on steel (left) and concrete substrates. Roughness is characteristic of application.

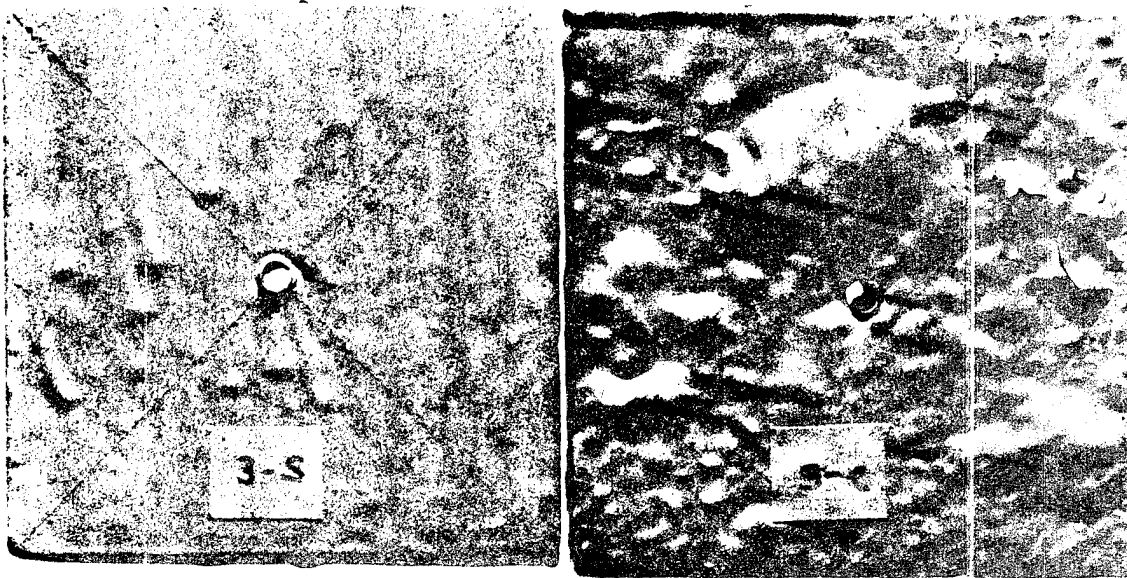
Figure 26. Blistering of proprietary, one-component urethane coating (No. C-13) on steel (left) and concrete substrates.

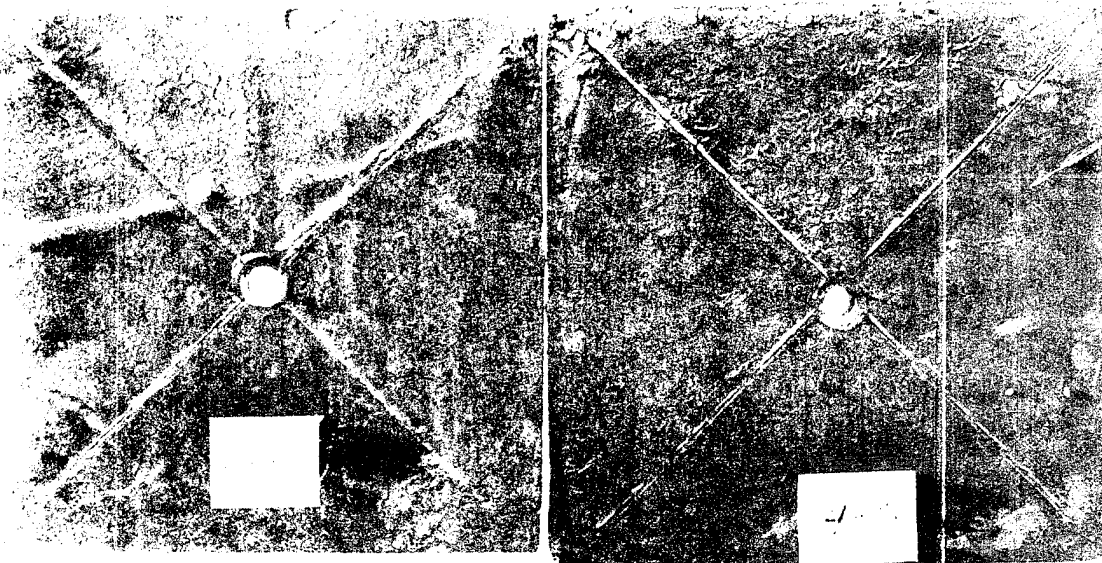
Figure 27. Cracking of coal-tar enamel coating (No. C-3) on steel (left) and on concrete substrates.

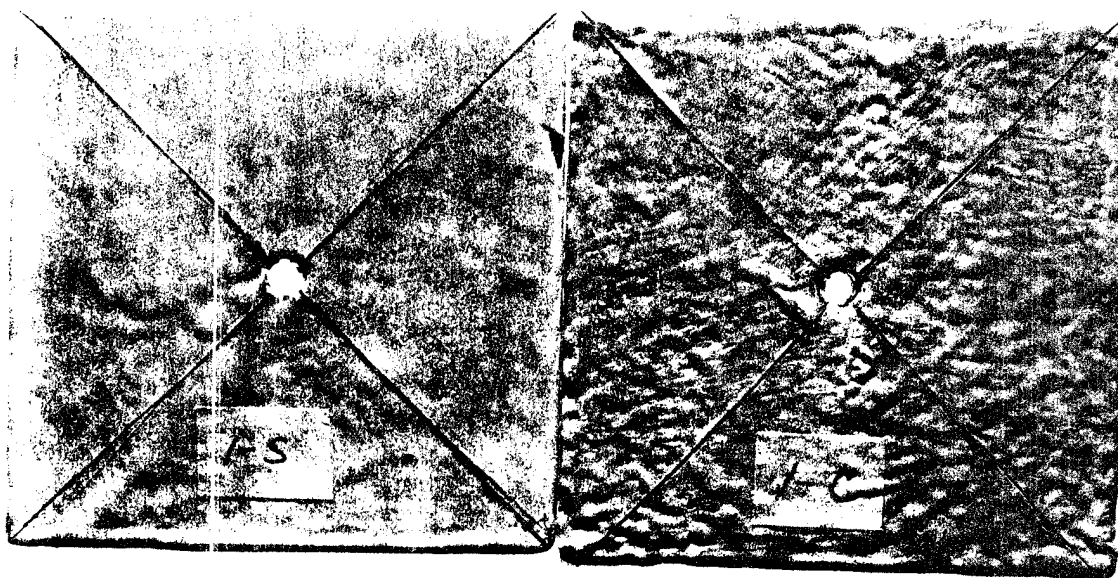
Figure 28. Defect-free phenolic-epoxy coating (No. C-12) on steel (left) and concrete substrates.

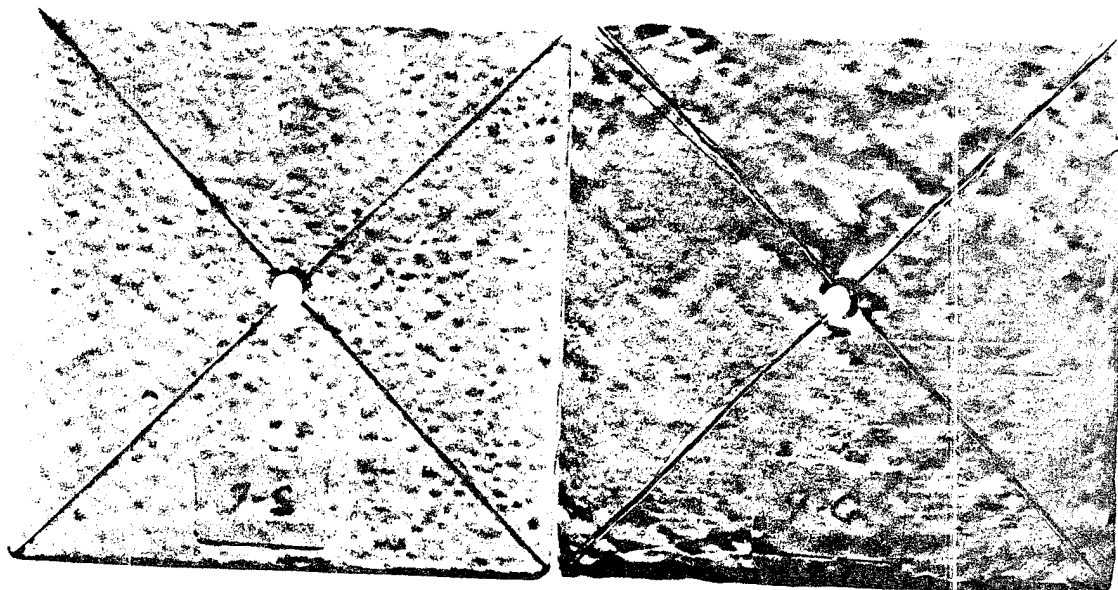
Figure 30. Blistering (topcoat only) of proprietary phenolic-epoxy coating (No. C-16) on steel (left) and concrete substrates.

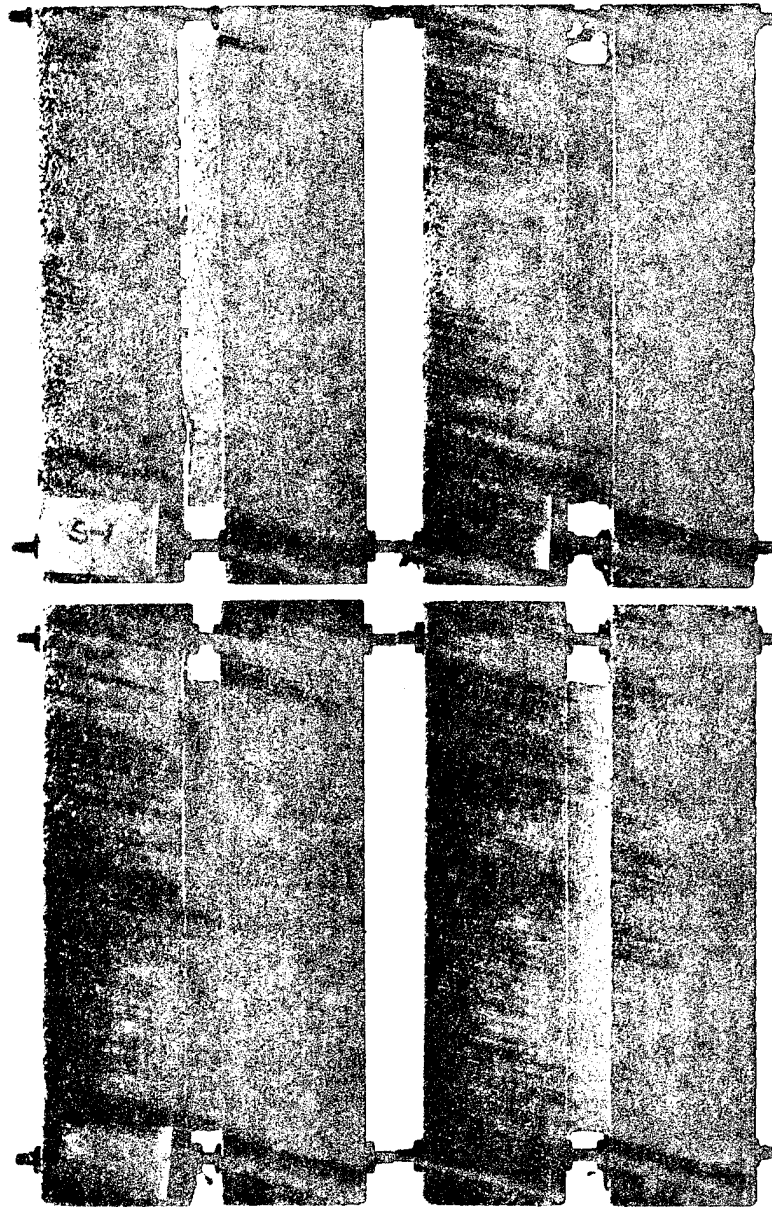
Figure 31. Typical joint sealer performance in these tests. S-1 is a two-component silicone sealant which has incurred bond failure, S-2 and S-3 show surface degradation of two-component polysulfide base material exposed in compressed (S-2) and stretched (S-3) condition and S-4 is intact one-component, low-modulus silicone.
